The ShakeOut Scenario

Supplemental Study

Woodframe Buildings

By
William Graf
URS Corporation
Los Angeles CA
May 2008

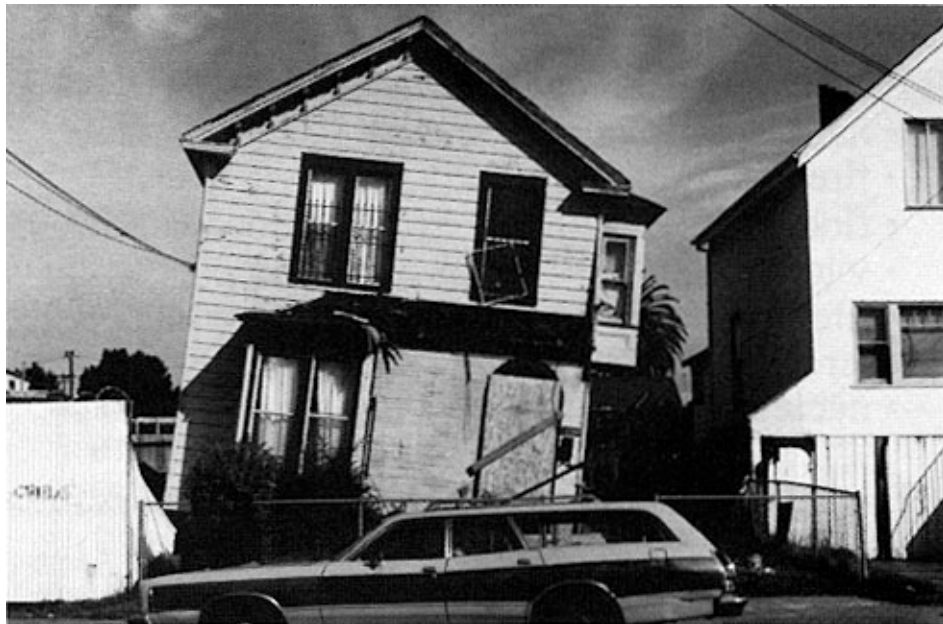
Figure 1. Dwelling in Oakland with Failed Cripple Wall, 1989 Loma Prieta Earthquake

- Bolting older homes (pre-1940) to their foundations and adding plywood sheathing to weak cripple walls where these exist.
- Connecting gravity posts to concrete foundation pads and floor beams in older homes and apartments with crawl spaces (see Figure 3).
- Strengthening older apartments with a soft/weak first story caused by tuck-under parking.

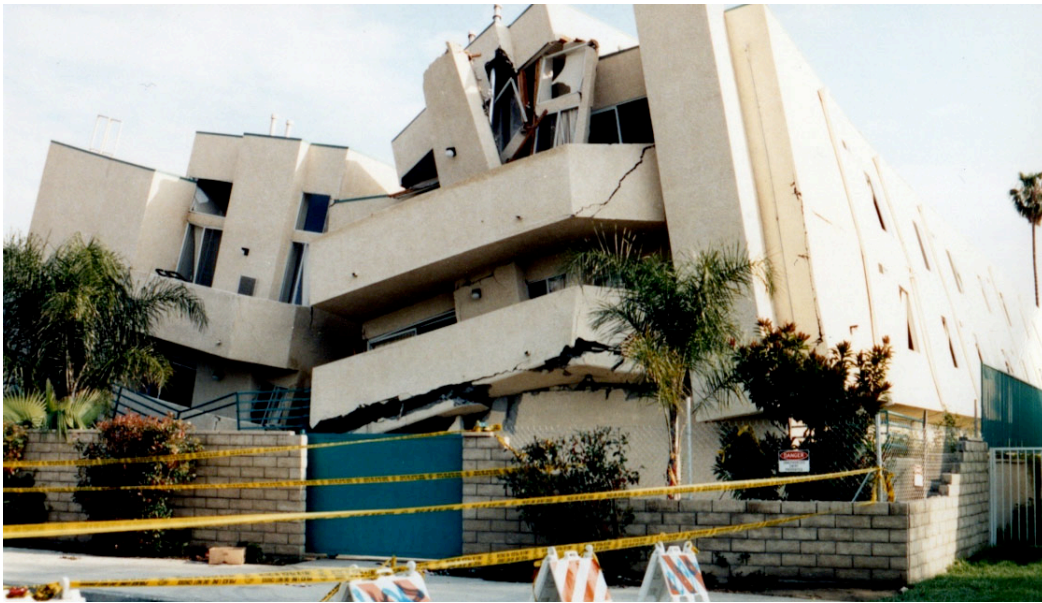
Figure 2. Apartment with Soft/Weak Story Collapsed in 1994 Northridge Earthquake

- Require seismic evaluation of apartments with tuck-under parking constructed prior to 1980, using the procedures in ASCE 31-03 or equivalent. Require seismic retrofit to remedy all soft/weak story conditions found.

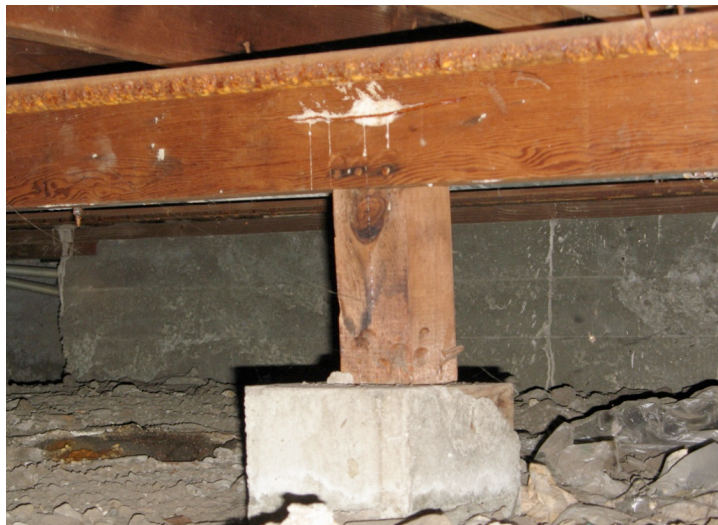
Figure 3. Post Beneath Apartment not Secured to Foundation Pad or Floor Beam

Cripple walls are another common feature in older wood-frame residential construction, pre-dating slab-on-grade construction. Cripple walls are a short wall occurring between the concrete or masonry foundation and a framed first floor (see Figure 7). They allow a crawl space useful for routing utilities into the building. Seismic weaknesses occur when the bottom plate of the cripple wall is not bolted to the foundation, where the sheathing of the cripple wall is weak (e.g., with straight sheathing), and where posts supporting interior walls and columns are not seismically secured to foundations and floor beams (see Figure 3).

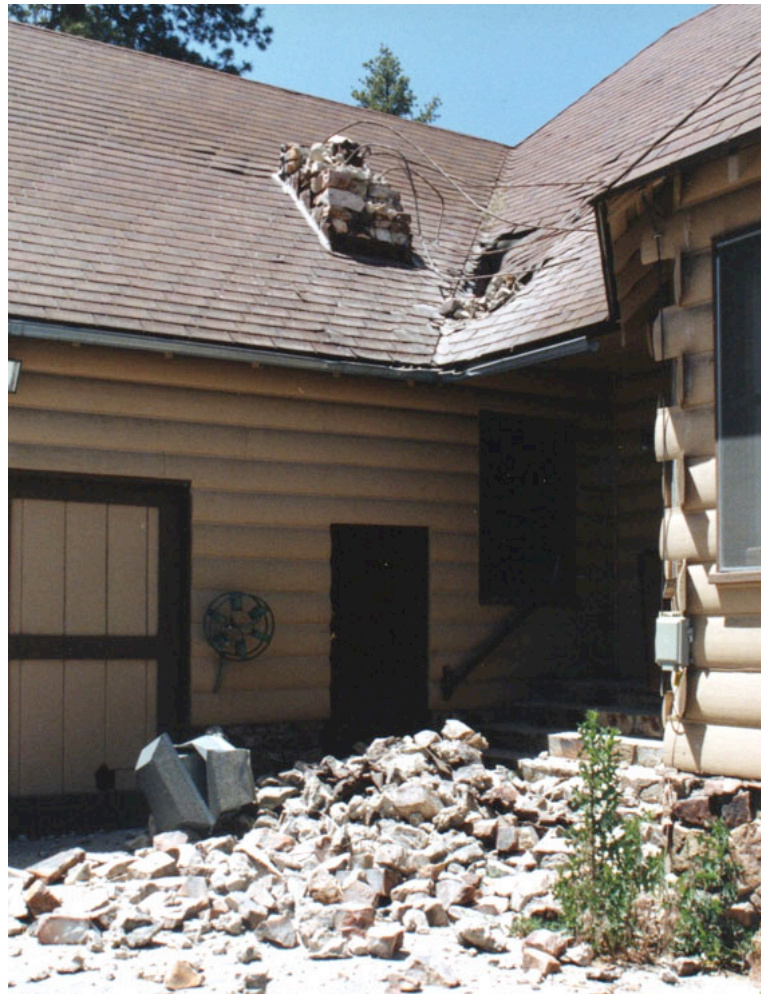
Figure 4. Shattered Chimney – 1992 Big Bear Earthquake

Chimneys are a common feature of residential wood-framed construction, and damage to chimneys has been noted in every large historical earthquake. Older chimneys are particularly prone to earthquake damage (see Figure 4), in part due to changes that have occurred over time in the design and construction provisions of building codes, as well as inspection and enforcement practices.

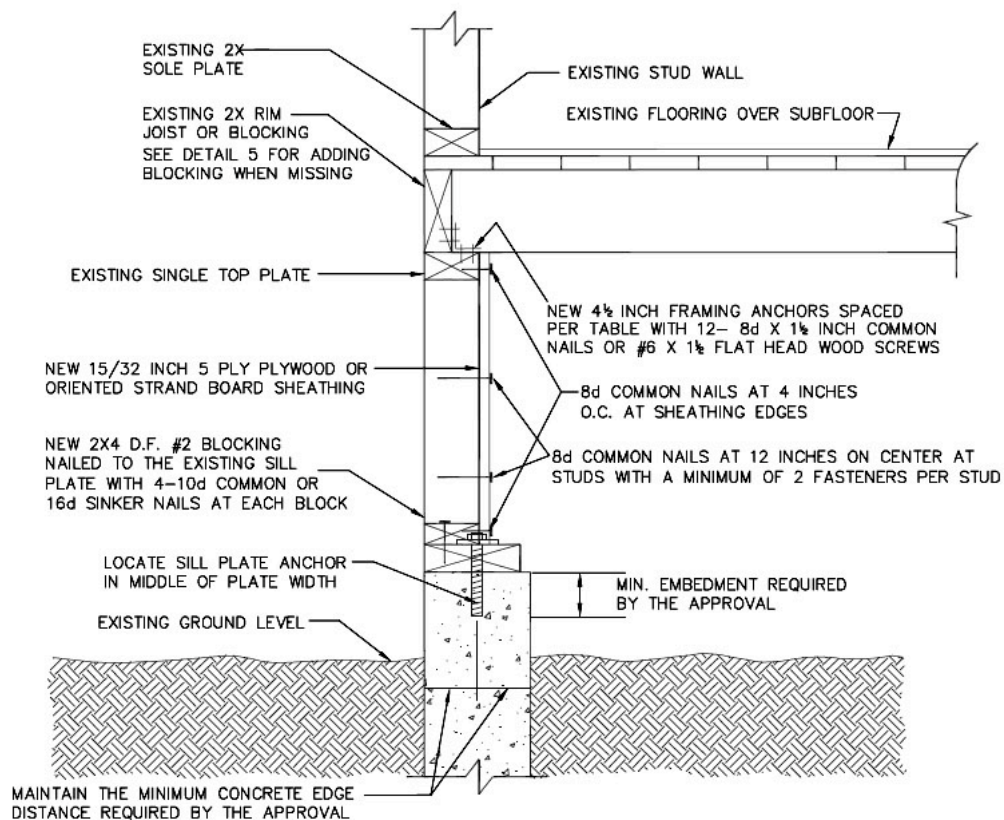
Figure 7. Excerpt from City of Los Angeles Recommended Rehabilitation Details: "Earthquake Hazard Reduction in Existing Wood Frame Residential Buildings with Weak Cripple Walls and Unbolted Sill Plates"

The seismic deficiencies associated with cripple wall construction are well known and documented in nearly all large historical earthquakes affecting wood-framed construction, yet to date no building jurisdictions have enacted mandatory rehabilitation ordinances. The City of Berkeley has a voluntary ordinance with tax incentives. Other jurisdictions like the City of Los Angeles Department of Building & Safety (LADBS) promote seismic rehabilitation of weak cripple walls by providing pre-approved retrofit details (see the excerpt in Figure 7. See also the discussion in FEMA 547.

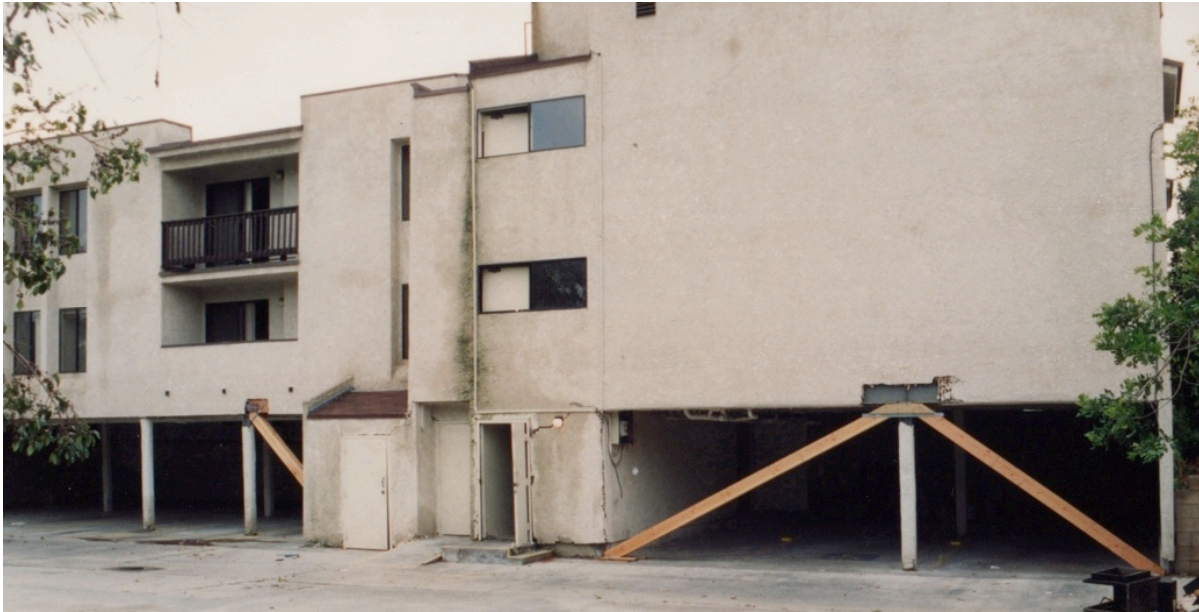
Figure 8. Apartment Building with tuck-under parking in the San Fernando Valley, damaged in the 1994 Northridge Earthquake, temporarily braced to prevent collapse.

During the 1960s and early 1970s, tens of thousands of wood-framed, multi-unit residential buildings were constructed with tuck-under parking. However, such designs introduce large open area on the ground level where walls along the garage fronts are discontinued, leaving only slender columns to carry the gravity loads. The designs interrupt the "load path," like cutting out one of the side of the box at its base. As a result, the structural system is weaker, and prone to large distortions and twisting motions, multiplying damage.
